FACILITY NAME* KODAK PARK

OWNER-OPERATOR NAME* EASTMAN KODAK COMPANY

October 31, 1995

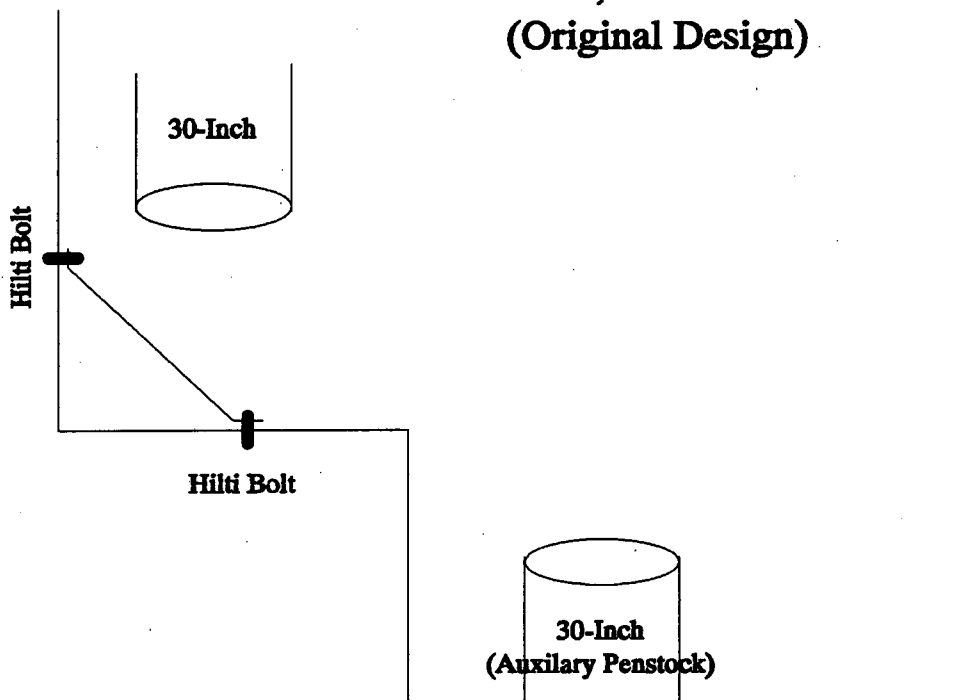
Figure 1A
NRC # 247320, NYSDEC # 9404576
(Original Design)

Diversion was initially established by sequentially turning on pumps. Upon activation of the 3rd pump (the 3rd pump was necessary to maintain a total diversion of wastewater flow) a failure of the diversion plate mounting occurred. As shown in Figure 1, the diversion plate moved out of position when the top Hilti bolts failed. When the plate moved to a vertical position, flow to the auxiliary penstock was impeded causing the wastewater to overflow through the manhole opening. This resulted in an estimated 12,500 to 20,000 gallons of industrial wastewater overflowing out of the manhole and traversing both down a steep embankment on the east side of B-96 and down the main vehicular roadway leading to the wastewater treatment plant. Of this amount, it is estimated that approximately one-half of the material flowed down the embankment and one-half flowed down the roadway. Of the amount that flowed down the roadway, a portion of that would have been re-introduced into the wastewater treatment plant via sewer drains located at the bottom of the hill.
